Submittal Title: PCT 2021 - 2022 MMO Final Report - South Floating Dock (SFD)

# 2022 Port of Alaska South Float Dock Construction Marine Mammal Monitoring

**Final Report  
October 2022**

Prepared by  
61 North Environmental  
Anchorage, Alaska

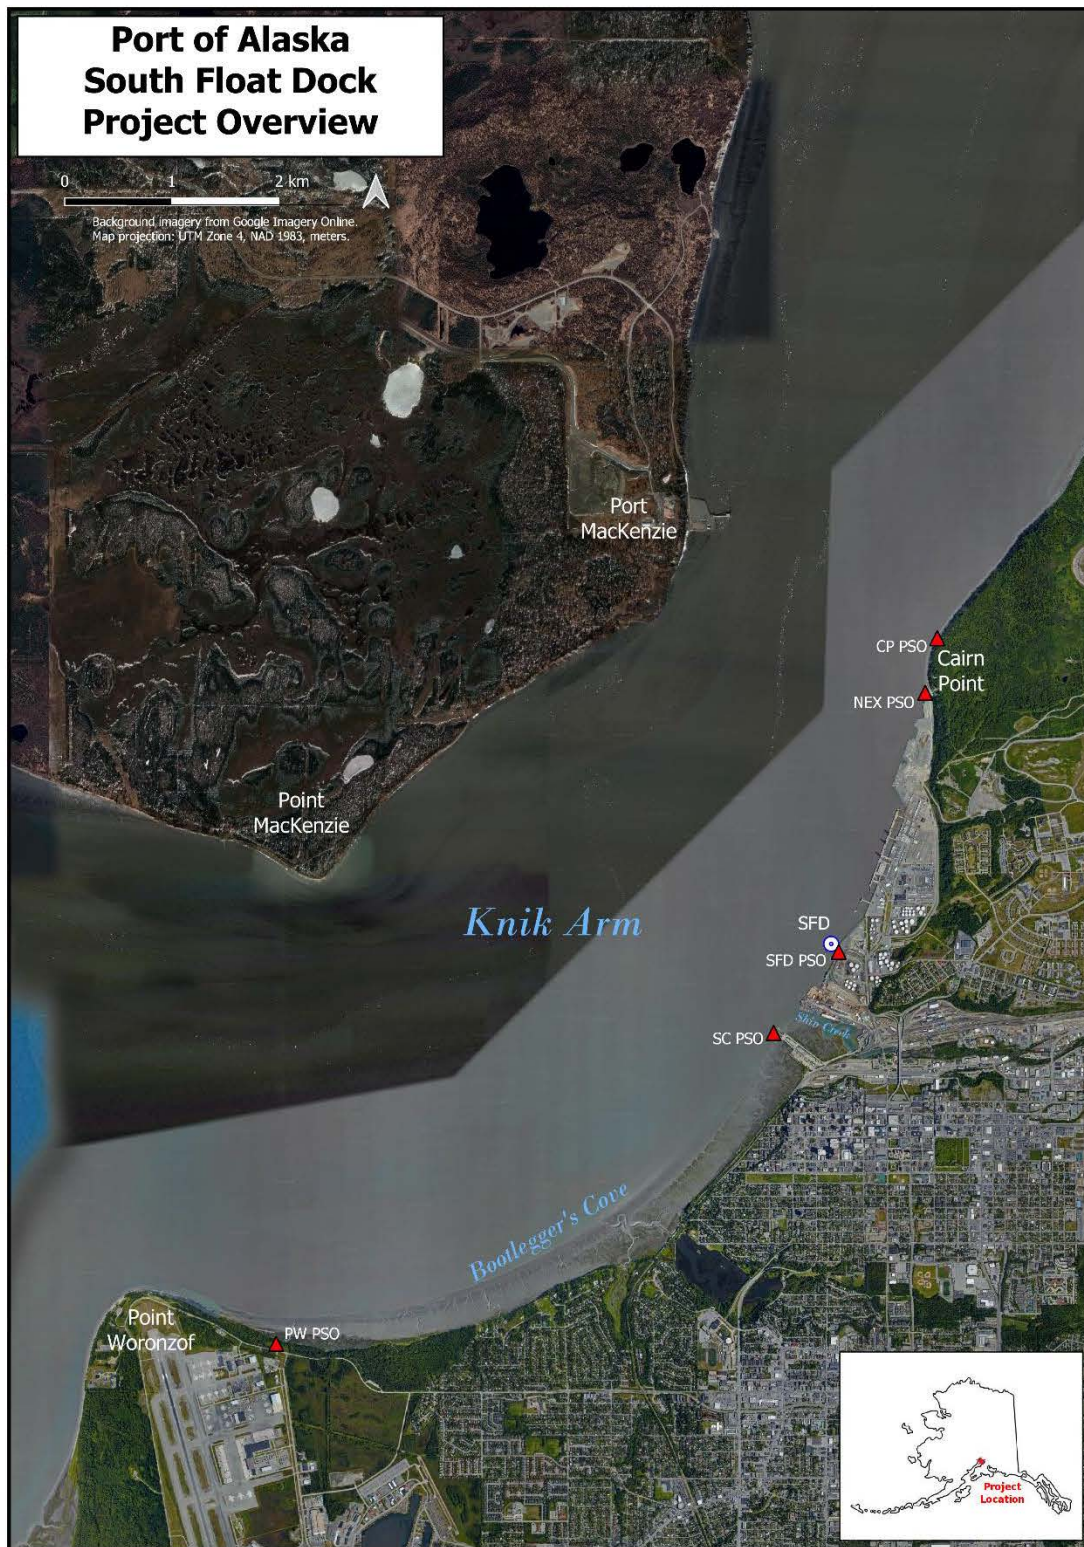
**Figure 1. SFD Project Location and Regional Landmarks**

installed over 13 non-consecutive days, between 20 May and 11 June 2022. The project location and regional landmarks are presented in Figure 1.

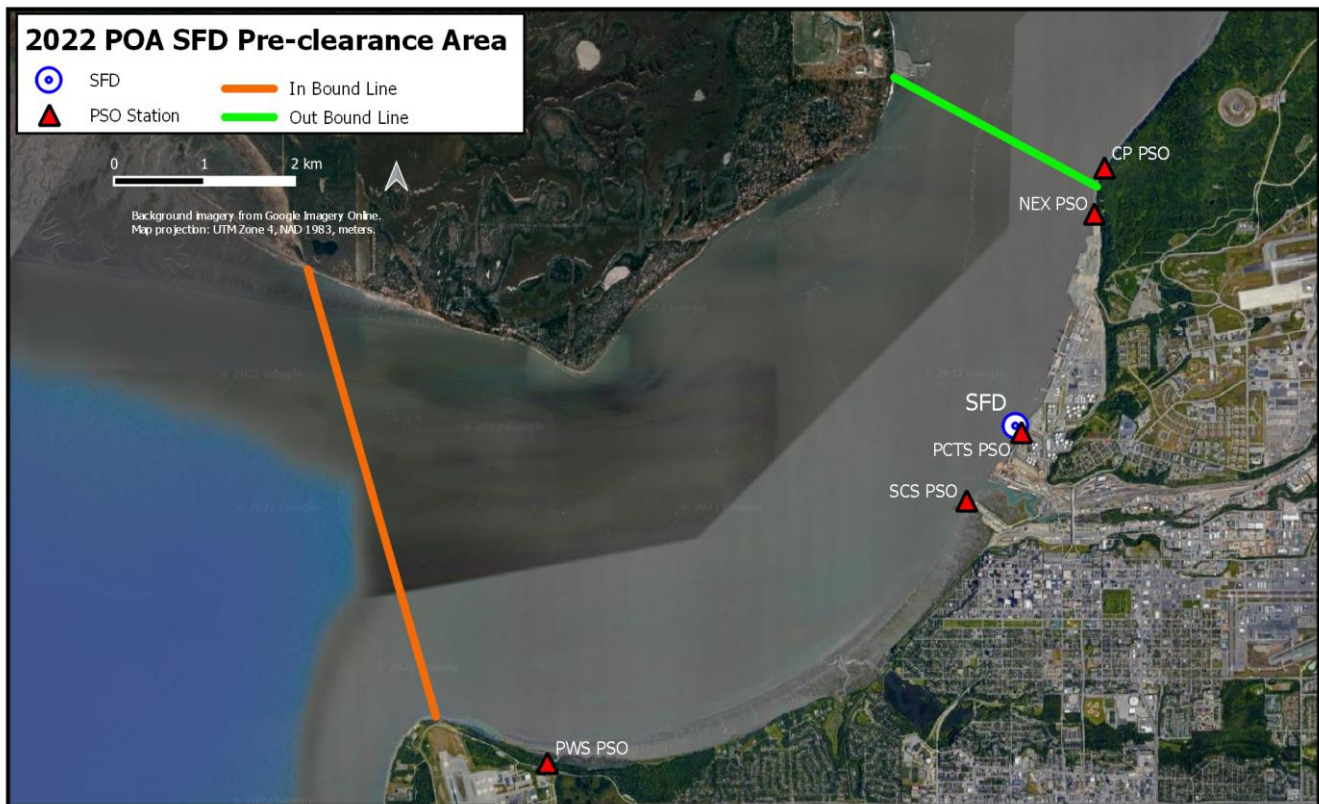
Figure 2. Boundaries of the Pre-clearance Area as defined in the IHA and BiOp.

One of the beluga-specific mitigation measures was monitoring of the pre-clearance zone between inbound and outbound lines defined in the IHA and BiOp (Figure 2). As described in the mitigation measures, the pre-clearance zone was monitored for 30 minutes prior to pile installation. If any belugas were sighted within the pre-clearance zone, pile installation could not begin until belugas were at least 100-meters outside of the applicable Level B zone and on a trajectory away from the Level B zone.

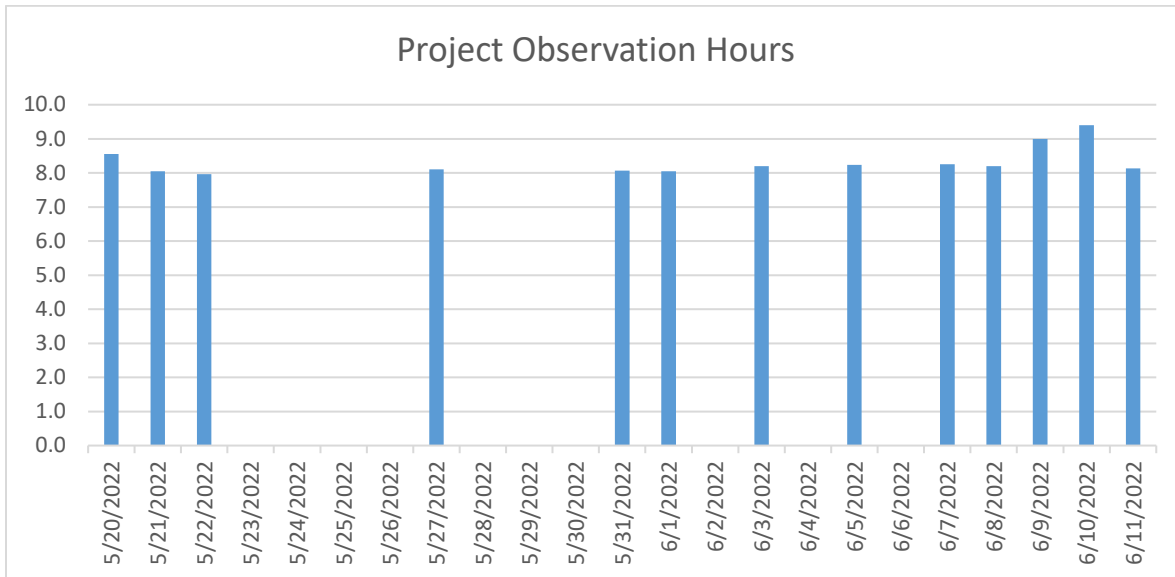
**Figure 4. Marine mammal observation hours during the SFD construction**

The hours of observation for each day of the project are listed in Table 4 and illustrated on Figure 4. The environmental conditions affecting observations are detailed below and in Appendix A.

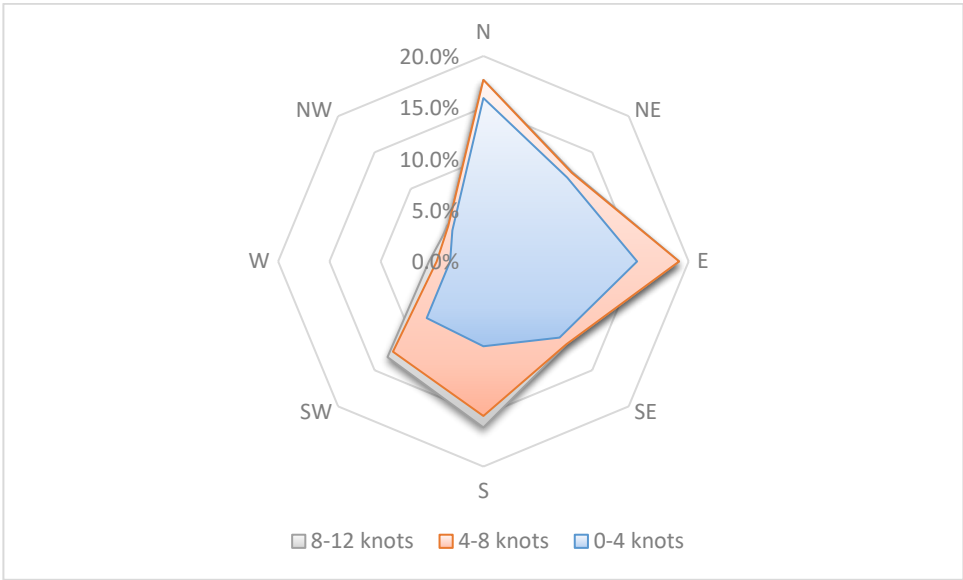
**Figure 5. Wind Speed Rose, NOAA Tide Station 9455920, Anchorage Alaska, During Observation Times in Reporting Period**

Wind speed, direction, and air temperature are not recorded by the PSOs as these meteorological data are available from the National Oceanic and Atmospheric Administration (NOAA) tide station 9455920 located at the POA, a few hundred meters from the SFD. The wind speed and direction for the 13 days worked during the reporting period were downloaded in six-minute intervals from the NOAA meteorological observations page for the Anchorage, Alaska tide station 9455920 (NOAA 2022) at the times observations were conducted. The air temperature during the reporting period was moderate with a minimum of 46.6°F, maximum of 67.8°F, and an average of 56.1°F. Approximately 77 percent of the wind speed records were between 0 to 4 knots, and 97 percent were below 8 knots. The wind data are summarized and presented as a wind rose in Figure 5, which shows that wind was variable coming nearly equally from the east, north, and south.

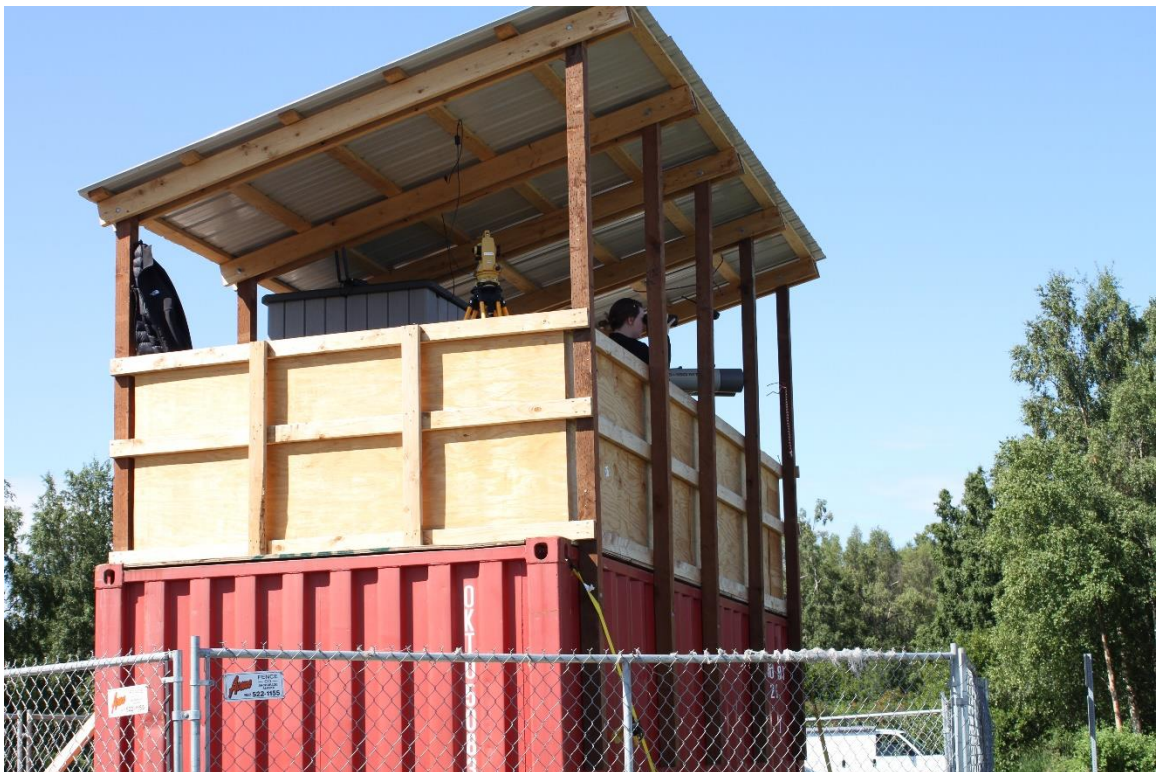
Photo 6. Point Woronzof PSO station

The Point Woronzof PSO station (PWS) was the same location used in 2020 and 2021 – the parking lot of the Downtown Anchorage Viewpoint, on land owned and managed by the MOA and Ted Stevens International Airport. The Ship Creek PSO station (SCS) was maintained at the end of the promontory south of the Ship Creek boat launch on land owned by the POA. The SFD was constructed very near the PCT PSO station (PCTS), located at the south end of the PCT construction area, near the cement dome. The PCTS was used by PSOs to monitor during the PCT construction in 2020 and 2021. The northern PSO station (NEX) was located at the northernmost portion of the POA known as the “north expansion.” The four standard monitoring locations (NEX, PCTS, SCS, and PWS) are presented on Figure 2. The IHA and BiOp prescribed a minimum of three PSOs at both the northern (NEX), southern (PWS), and a minimum of two PSOs at the PCTS station. Three PSOs were stationed at SCS, resulting in 11 total PSOs on duty for all monitoring and pile installation events.

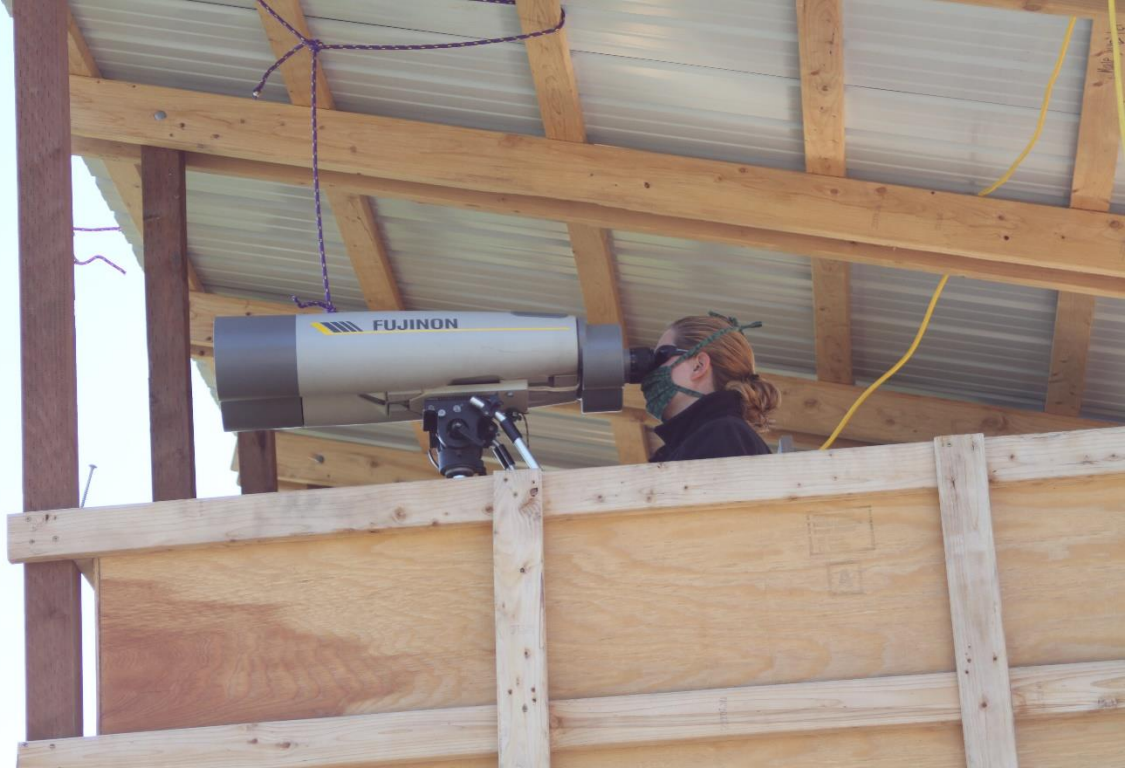
Photo 7. Fujinon 25X150 MT-SX “big eye” binoculars at Point Woronzof

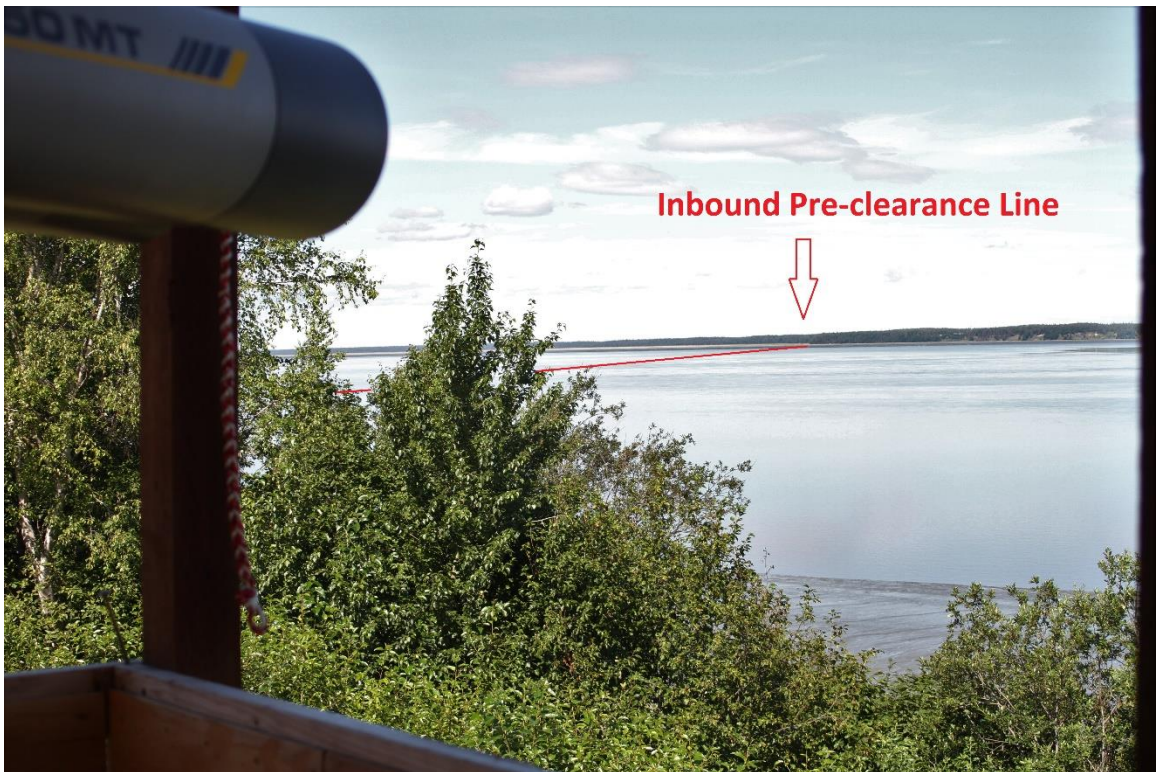
Photo 8. View of In-bound Pre-clearance Line from Point Woronzof PSO Station

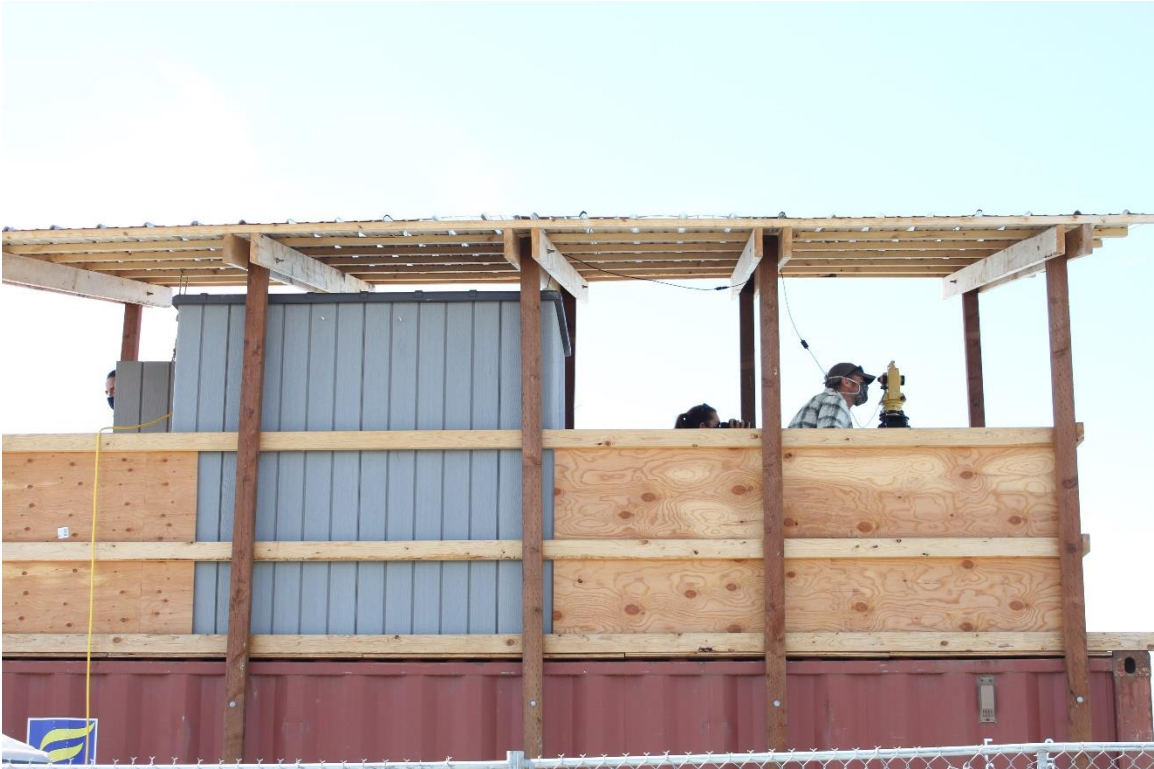
Photo 10. PSO using the digital theodolite at Ship Creek PSO station

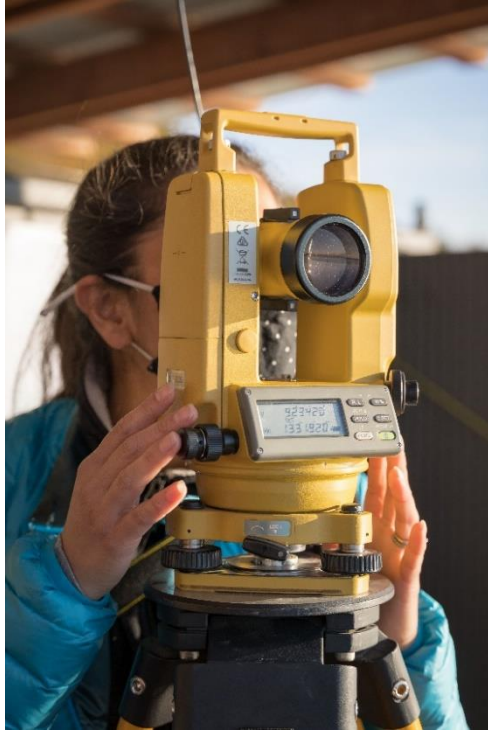
Photo 13. PSO using Topcon DT-205 digital theodolite (Photo Credit: Kristina Smolenski – The Photo Gecko)

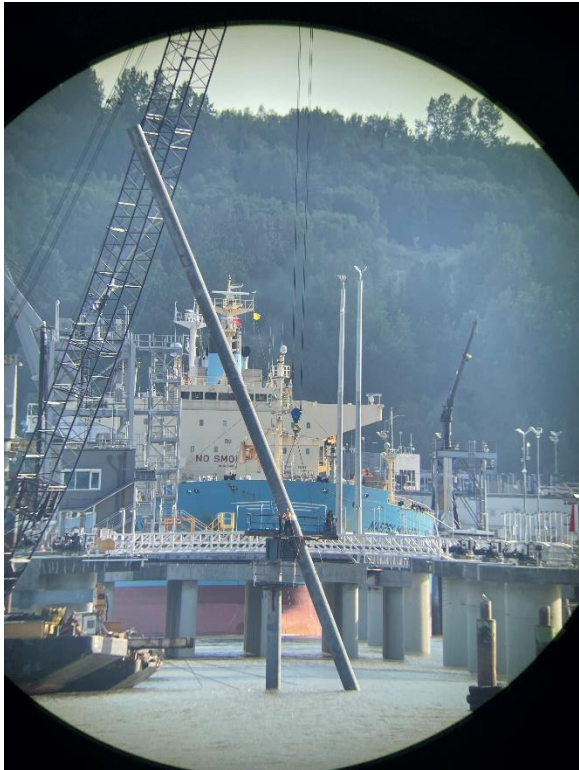
Photo 14. Preparing to install battered pile. View towards SFD from Ship Creek PSO station through Fujinon 25X150 MT-SX “big eyes”

No temporary piles were installed to facilitate the installation of the permanent SFD piles. Instead, PPM utilized a "horn" template mounted on the bow of the construction barge for the permanent piles. This methodology is only feasible for specific and limited conditions and was possible in this instance due to the layout of the SFD piles and because a four-point anchor mooring system was in use for the construction barge. It is noteworthy that the installation method avoided the vibratory pile driving and removal of six temporary 24-inch or 36-inch piles, which eliminated an estimated 12 hours of vibratory hammer use that would have otherwise been conducted.

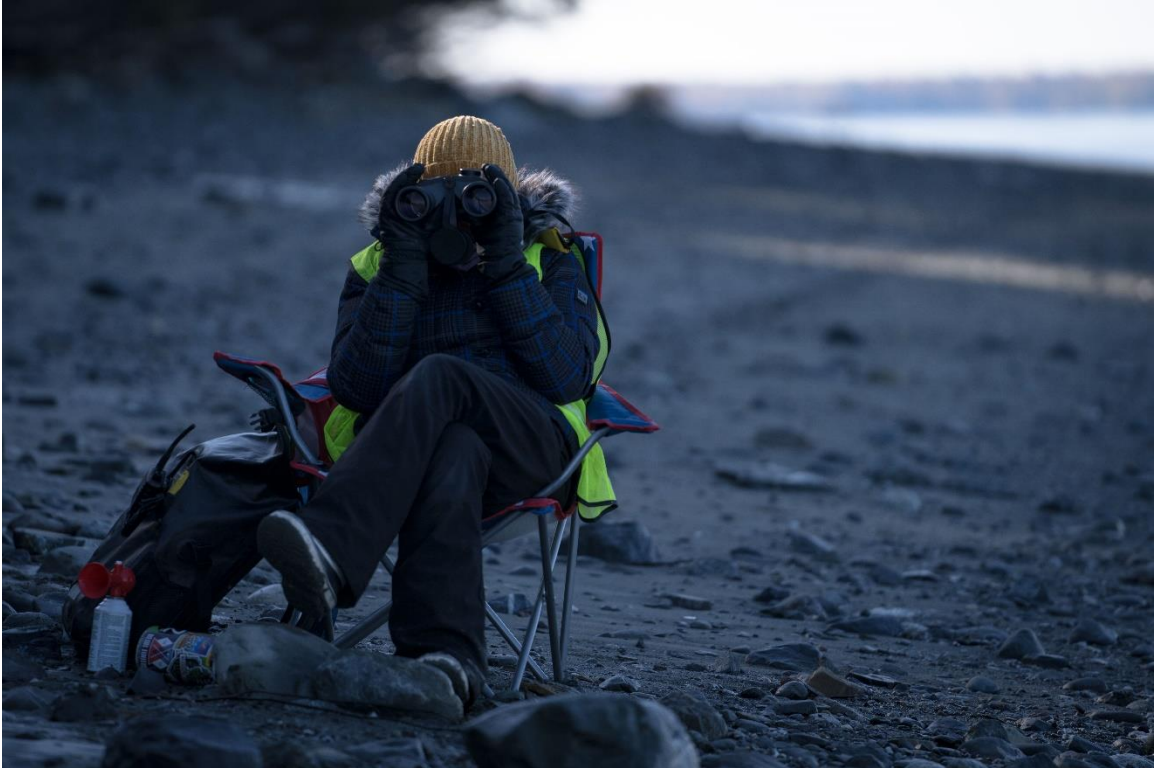
Photo 18. PSO at the CP remote station, Cairn Point Beach (Photo Credit: Kristina Smolenski – The Photo Gecko)
