***Acoustic Monitoring and In-situ Exposures of  
Juvenile Coho Salmon to Pile Driving Noise at the  
Port of Anchorage Marine Terminal Redevelopment Project  
Knik Arm, Anchorage, Alaska***

October 2009

***October 21, 2009  
12684-03***

Prepared by  
**Hart Crowser, Inc./Pentec Environmental**

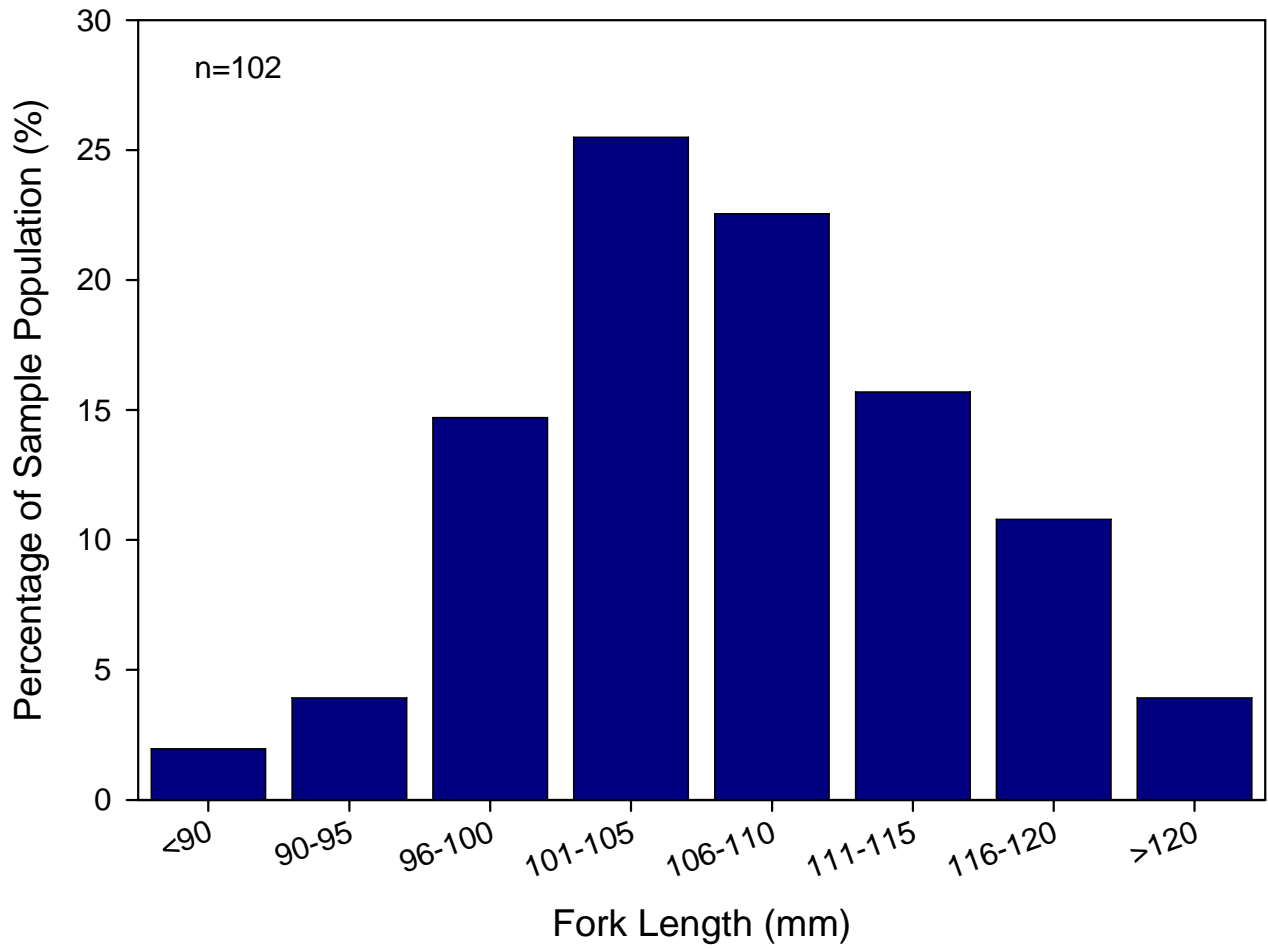
<b>PENTEC ENVIRONMENTAL</b>	Figure <b>4</b>

Port of Anchorage Fish Study Anchorage, Alaska	
<b>Size Distribution of Coho Salmon used in the Live Cage Studies</b>	
12684-03	9/09

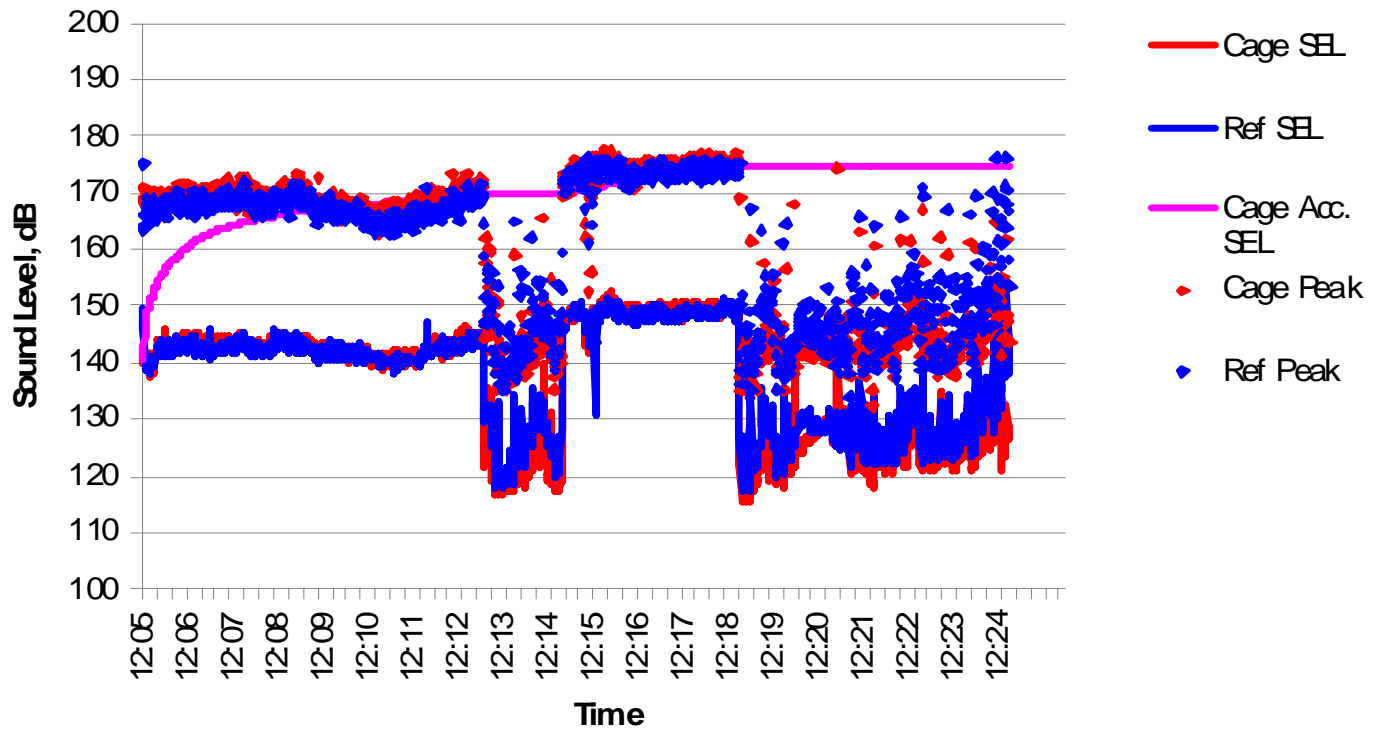
<b>PENTEC ENVIRONMENTAL</b>	Figure <b>5</b>

**Figure 5. Sound charts for Batch 2.**

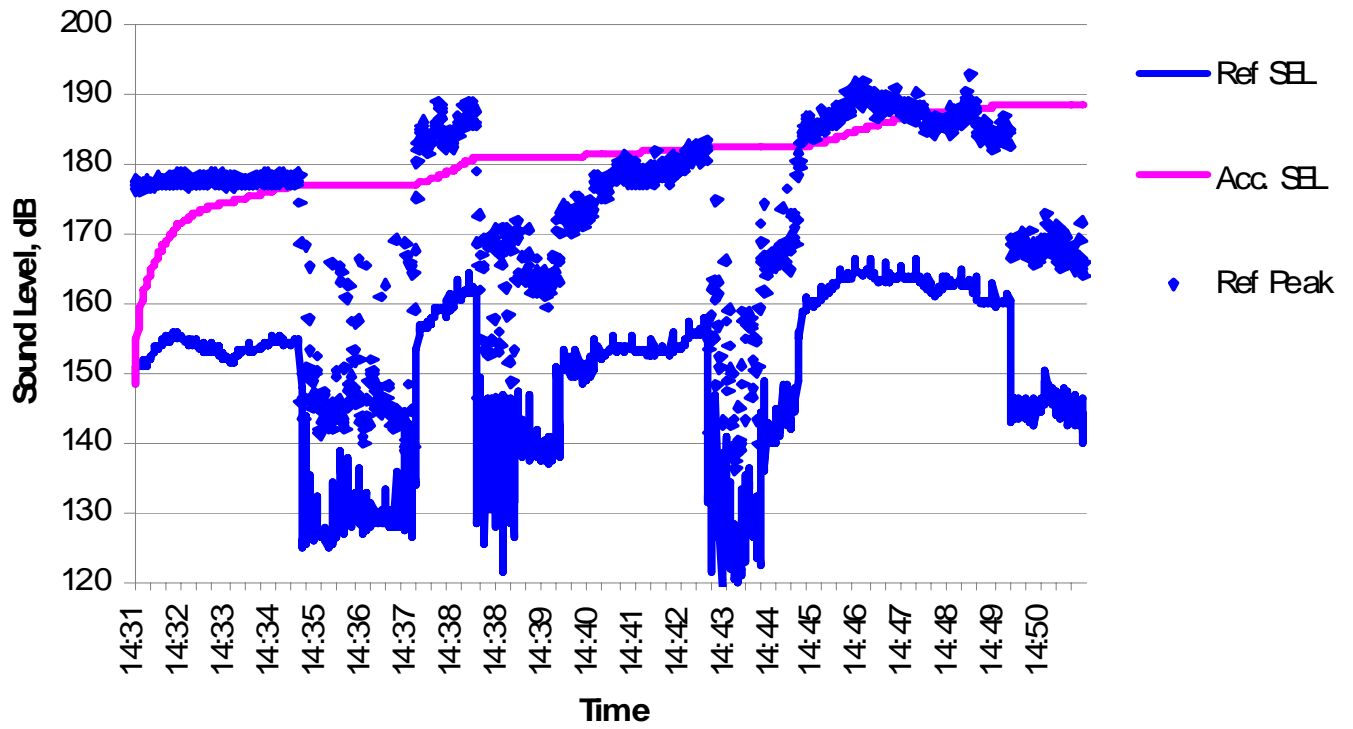
<b>PENTEC ENVIRONMENTAL</b>	Figure <b>9</b>

Port of Anchorage Fish Study Anchorage, Alaska	
Sound Charts for Batch 7	
12684-03	9/09

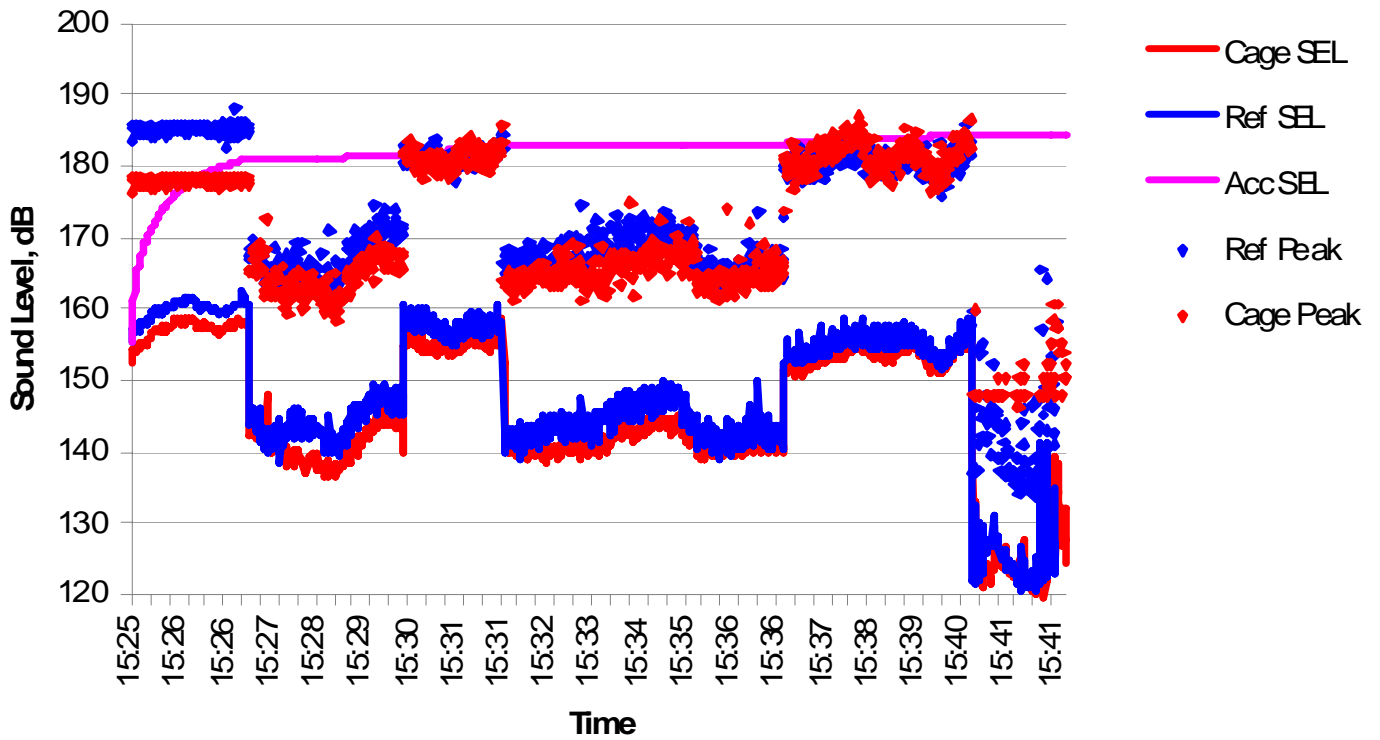
<b>PENTEC ENVIRONMENTAL</b>	Figure <b>11</b>

**Figure 11. Sound chart for Batch 9.**

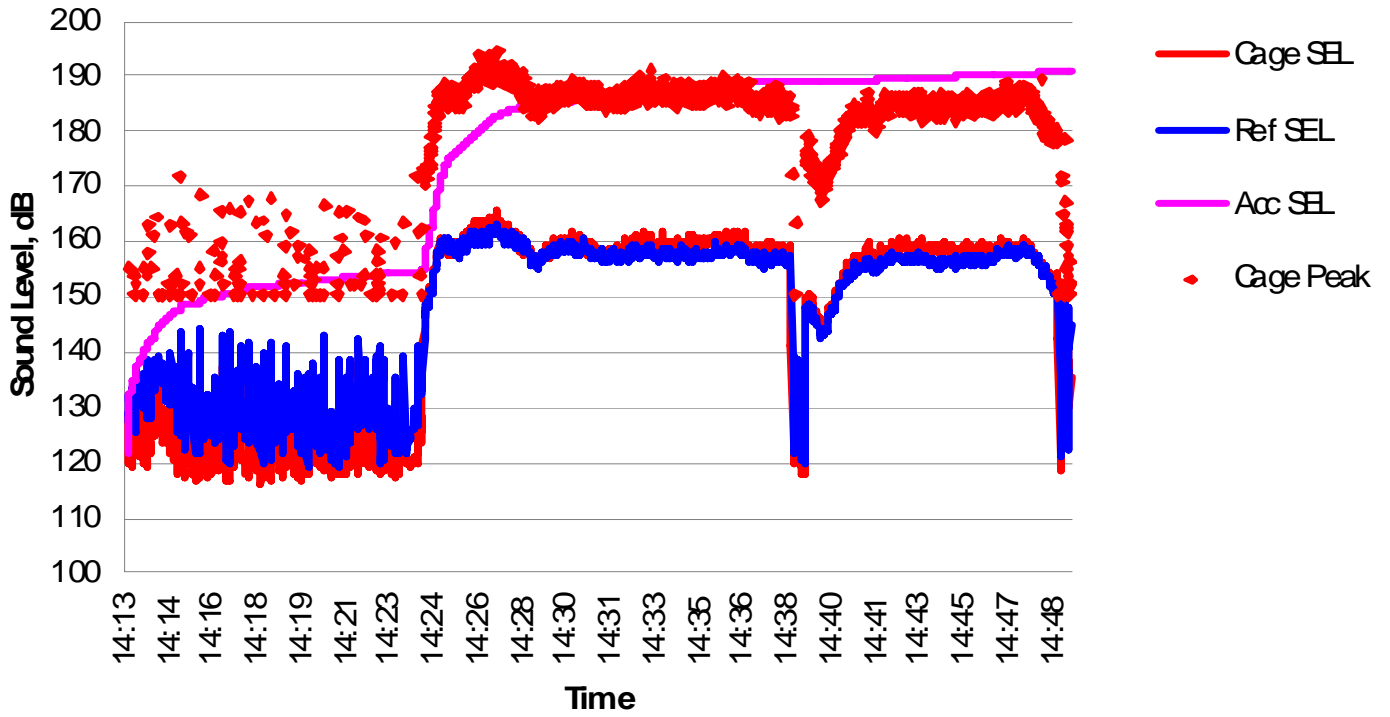
<b>PENTEC ENVIRONMENTAL</b>	Figure <b>16</b>

Figure 16. Sound chart for Batch 15.

Test 15 simulated a worse-case exposure scenario, in which fish were held quite close to pile driving activities for an extended period. The greatest accumulated SEL (190.6 dB) was reached in Test 15 where the test cage was held near the sheet pile wall, about 4-5 m from the large impact hammer, driving a pile that was at refusal, for over 30 minutes and 1,458 strikes (Table 2). This exposure is unrealistic for Knik Arm outmigrating salmon, but was conducted in an attempt to create exposures that would cause measurable injury of the test fish. No mortality or internal abnormalities were observed

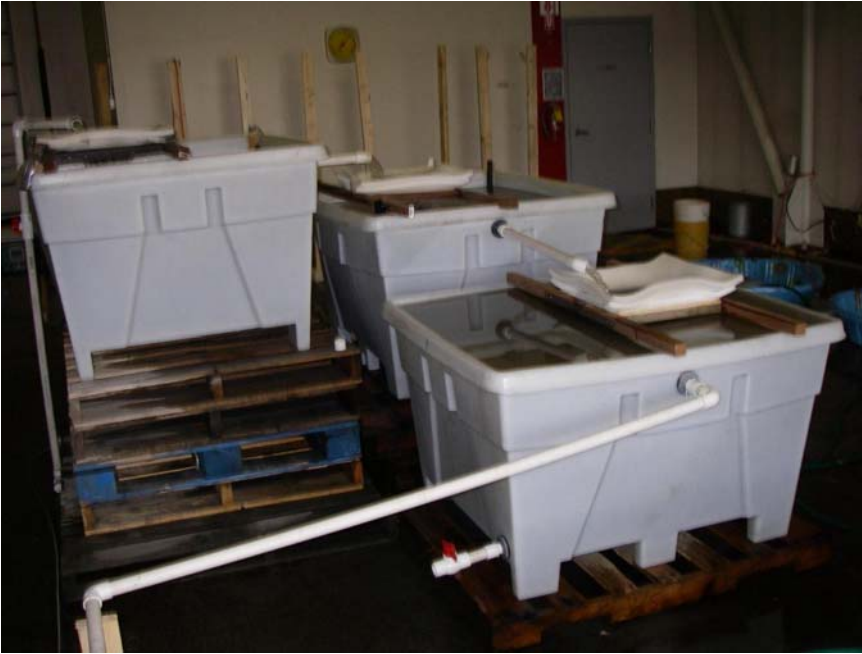
Photograph 1 - Wet lab with series of three setting tanks.

One of the biggest challenges in constructing a useful wet lab for observing post-exposure juvenile salmonids in Knik Arm seawater is reducing the highly turbid ambient conditions to the point where the fish could be observed in the water column. During the 2008 trial study, a system of two settling tanks with baffles to reduce movement of the water and allow for settling of particulates was constructed, and turbidity measured at different points in the set up. There was a substantial decrease in turbidity seen between ambient Knik Arm water and the observation pools (Pentec 2008). Based on these findings, it was determined that the baffle system was partially effective at reducing turbidity, but it was hoped that clarity could be improved with the addition of a third tank and a filtration system. Particulate filters were added to the set up in 2009, but it was difficult to provide enough filtration to account for the increased flow needed to supply water to the entire lab system. With the entire lab running, a total of 13 observation tanks (relatively low flow) and 2 holding tanks (relatively high flow) required an order of magnitude higher flow compared to 2008 flow through the settling tanks. Therefore, for a given

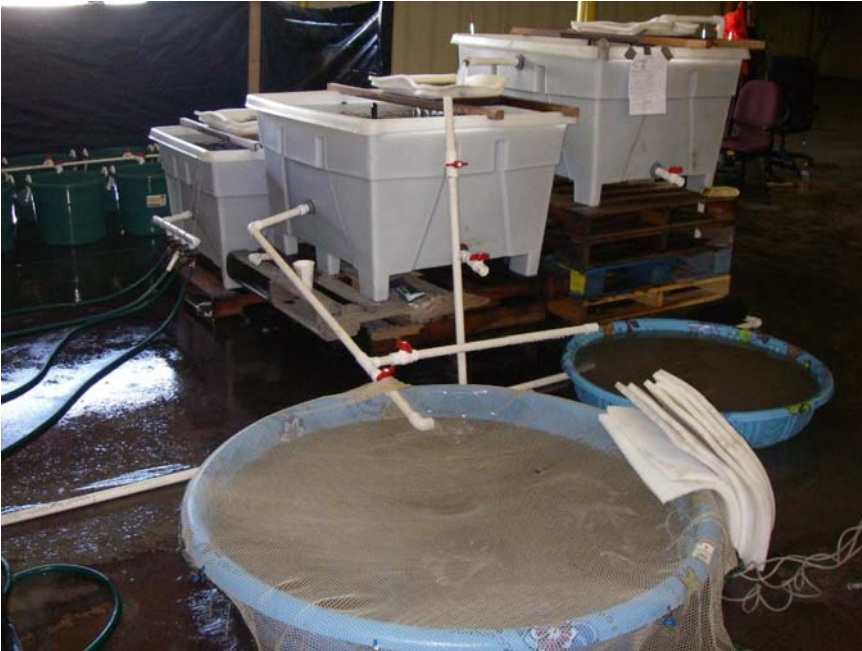
Photograph 2 - Fish holding and fasting tanks prior to exposure.

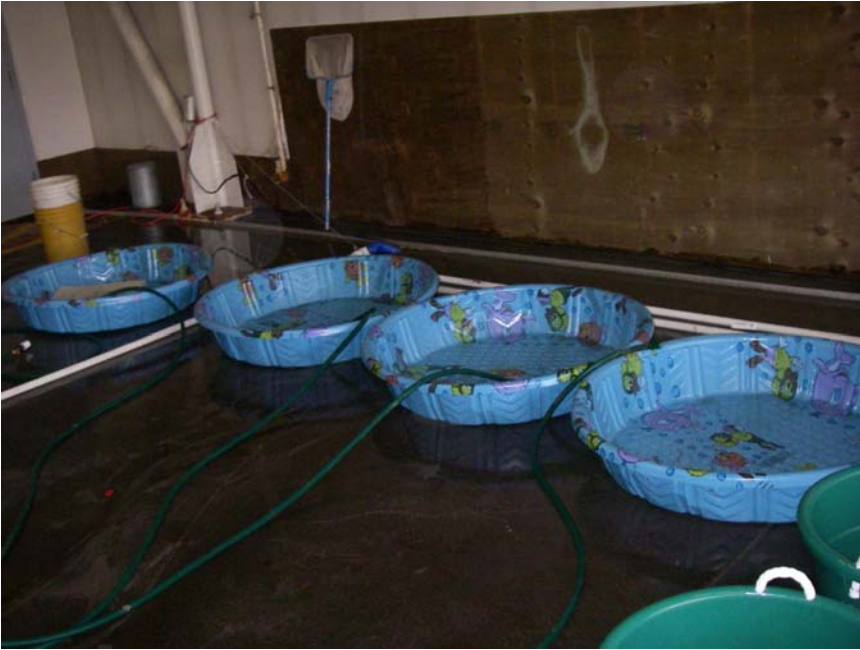
Photograph 3 - Short-term observation tanks.

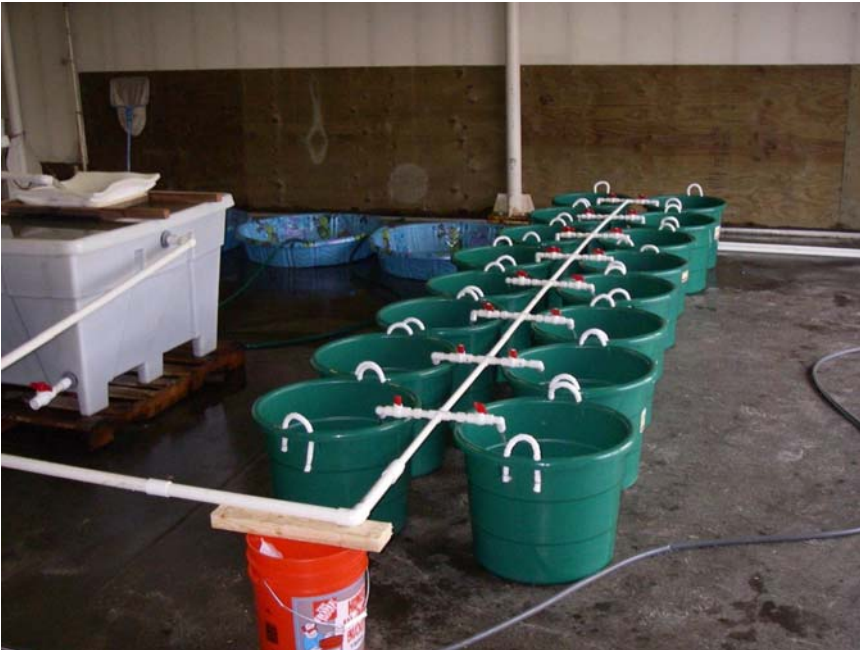
Photograph 4 - Long-term observation tanks.

The main purpose of the long-term observation periods was to document any delayed mortality as a result of the exposures. In addition to checking for mortalities, the fish were also checked for any gross abnormal behavior. There was no delayed mortality of any of the 163 fish that were put into the long-term tanks and no abnormal behavior was observed in these fish. Fish appeared calm, which is consistent with acclimation times observed in the short-term pools. Also, because the long-term tanks had taller sides that did not require a cover of netting material (Photograph 4), the fish were not disturbed by removal of the cover prior to observation.

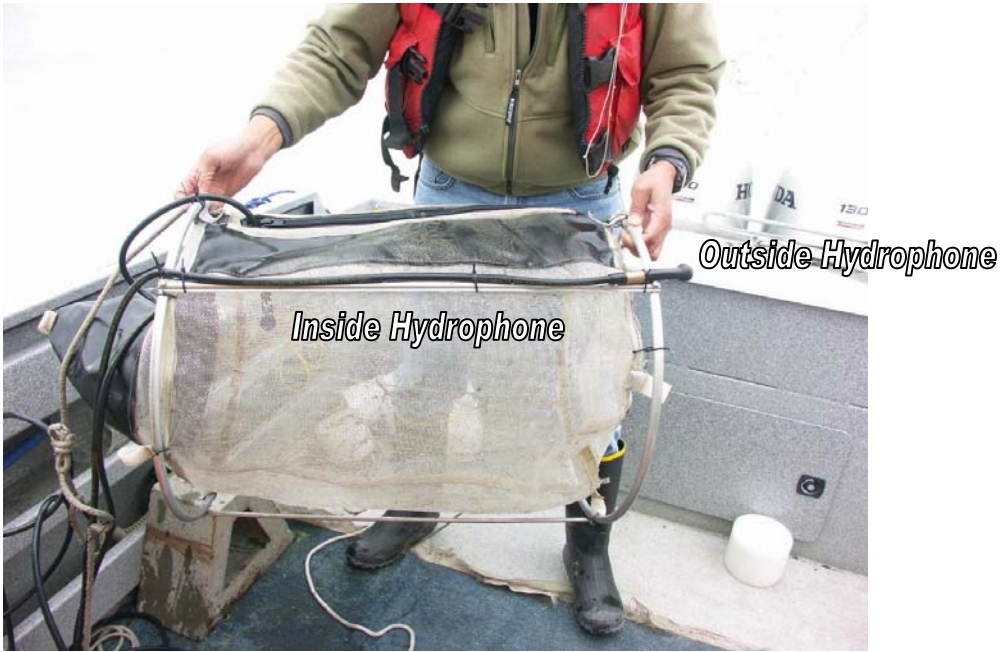
Photograph 5 - Live exposure cage with inner and outer hydrophones.

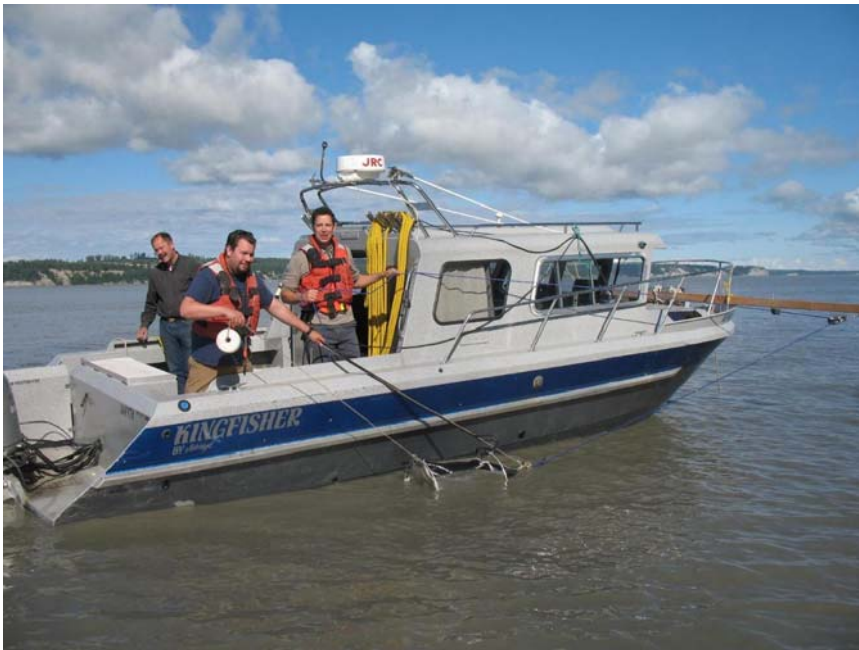
Photograph 6 - Live cage deployment set up on the *R/V Jakayte*.

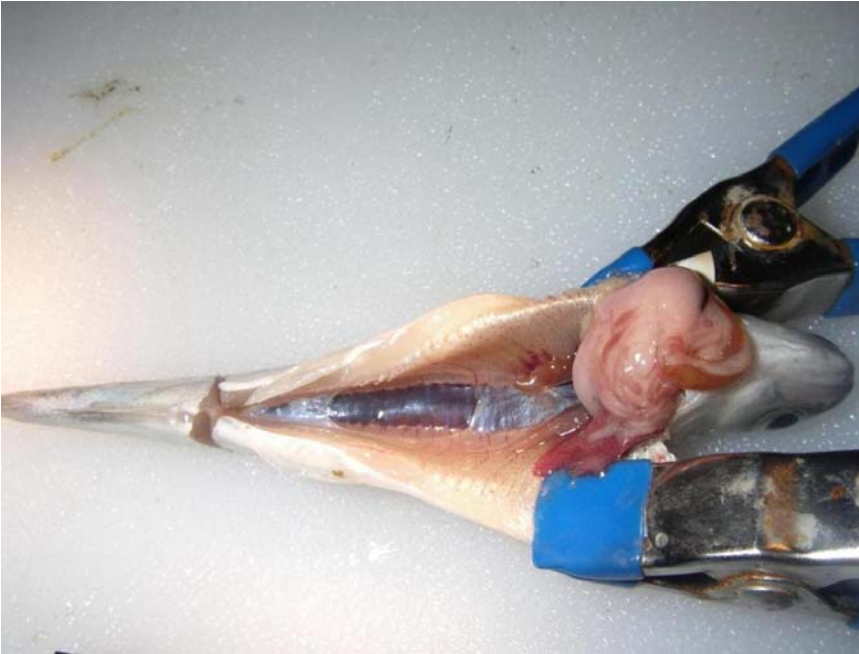
Photograph 11 - Batch 4 test fish with light internal hemorrhaging (Level 1) in the body wall near the heart.

- Post-exposure necropsies found slight body wall hemorrhaging in 3 fish exposed to pile driving noise (3.9 percent) and 2 reference fish (10.5 percent). No dose-dependent relationships were observed in the exposed fish with abnormalities. There was no evidence that these abnormalities were caused by barotrauma; they likely resulted from normal handling during the live cage experiments.

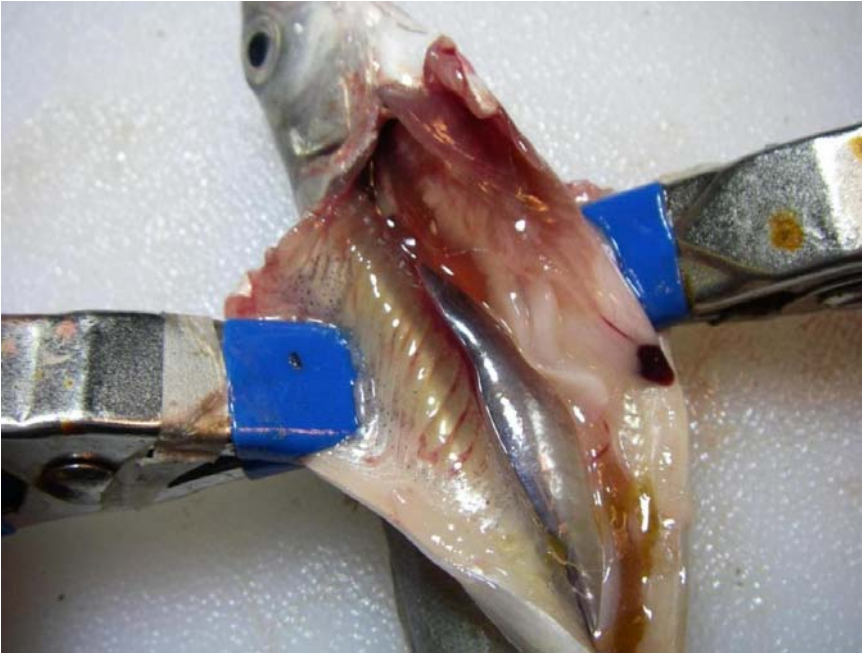
Photograph 12 - Batch 5 reference fish with light internal hemorrhaging at the base of the kidney.

Photograph 13 - Batch 5 reference fish with light internal hemorrhaging at the base of the kidney.

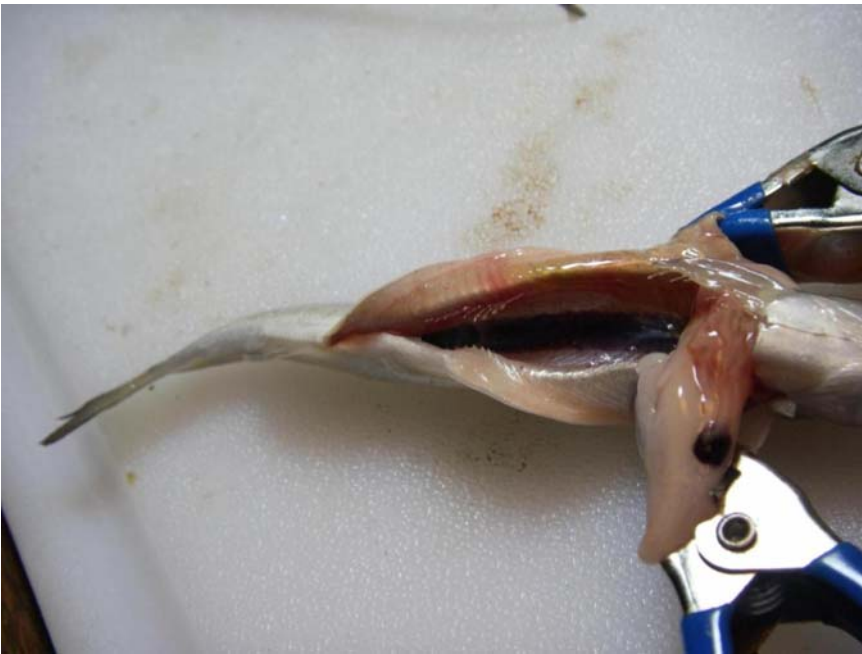
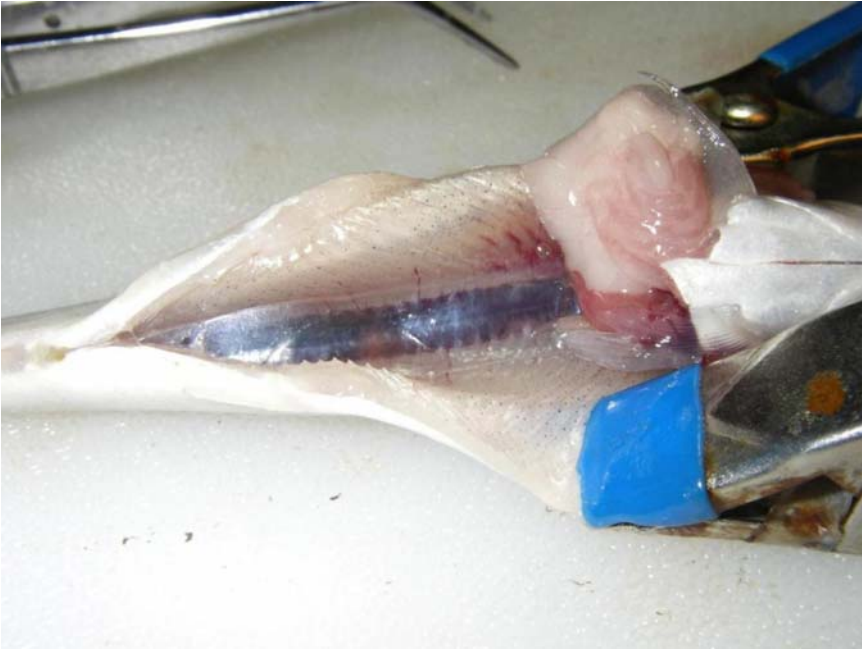
Photograph 14 - Batch 6 test fish with light internal hemorrhaging on dorsal portion of body wall.

Photograph 15 - Batch 6 test fish with light internal hemorrhaging on the dorsal anterior of body wall.
